MHT Number HO-672

| Name and SHA No. MD 97 over Patuxent River/13038 |

# INDIVIDUAL PROPERTY/DISTRICT MARYLAND HISTORICAL TRUST INTERNAL NR-ELIGIBILITY REVIEW FORM

Bridge No. 13038 (HO-641) Roxbury Mills Howard County, Maryland

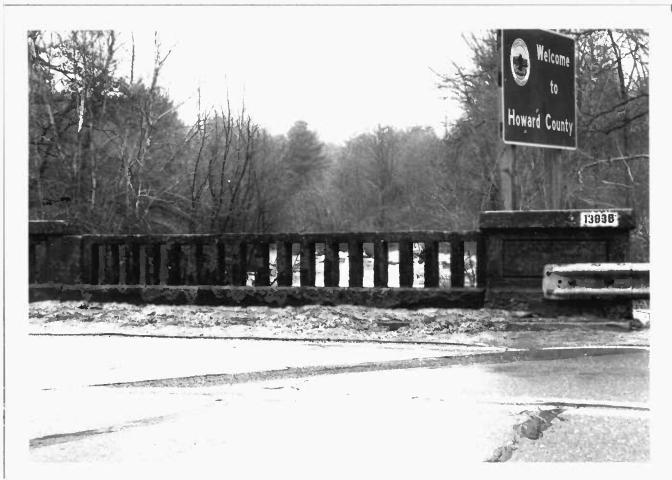
Lobell Budge 15038 Howard County, mD R. Suffren 2/14 negrat mostate Herry Admin Defact of West Paraper wall

The balustrade is 3'-2" from the construction joint of the deck. (see Attachment 3, Photo 1) Each rail opening is 6" wide and approximately 1'-0" high. The cap is 1'-2" wide, 5 1/2 " high, and extends over each 13 space segment of the parapet. The enclosed photographs illustrate the deteriorated condition of the parapets. The expansion joints have slipped, the majority f the balustrades are spalling, the coping on both side have spalling, the cap on the first segment of the eastern parapet is missing, and the missing concrete at the expansion joints are causing minor shifts in the bridge. The parapets need patching and in some cases replacement.

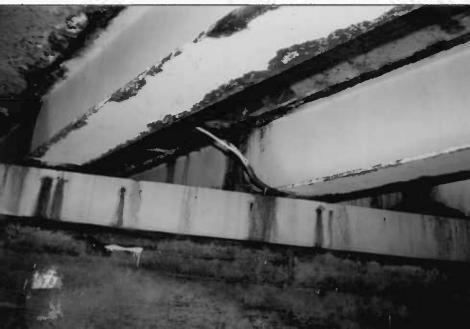
Span 1, Beam 5 over Pier

Typical Rust, scale

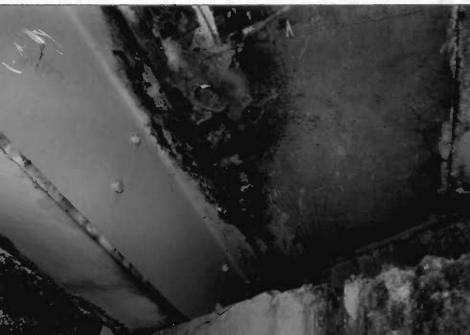
The <u>Historic Bridge Context</u> states that the rolled concrete encased longitudinal I-beams is of primary importance contributes to the essential characteristics of a concreted encased rolled I-beam. An April 1994 inspection report detailed the condition of the I-beam. The I-beams are approximately 43'+/- in length with a 20" x 3/8" web plate. The top flange of the I-beam is integrated into the deck of the bridge. Several beams have deep pitting with some sectional loss on the bottom flanges. There is additional sectional loss near the bearing area (The area where the girders meet with the substructure). 6 ( All numbers are from north and west. See Attachment 3, Photo 3) has the bottom flange bent upwards 1" . Beams # 1 & # 8 are The exterior I-beams are fully encased in the exterior I-beams. concrete (see Attachment 3 Photo 4). The exterior beams have spalling cracking and erosion throughout.

40-641 md Rte 97/ Patuxent Beam I along deck

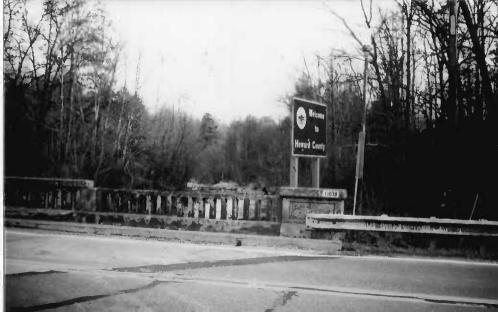
MD 97 over Paturent 5 E Quad DO-641 Bridge # 13038 S.E. Elevation Missing Parapet
